December 13, 2016

## ANNUAL INSPECTION REPORT DALLAS FLOODWAY

**1. General.** The annual Operations and Maintenance inspection of the Dallas Floodway was conducted on 24-25 October 2016, in accordance with the provisions of Title 33 Code of Federal Regulations, section 208.10, as it applies to local flood protection works constructed by the United States. Mark Sissom, P.E., Brian Brasher, P.E., and David Little, P.E., represented the U.S. Army Corps of Engineers. Representatives from the city of Dallas included Dhruv Pandya, Ricky McRay, and Jose Chio. The inspection was conducted under partly cloudy skies and a temperature of 76 degrees. The inspection included the East and West Levees, the Central Wastewater Treatment Plant Levee, the pump stations, and interior drainage features. Photographs taken during the inspection and summary rating sheets are included herein.

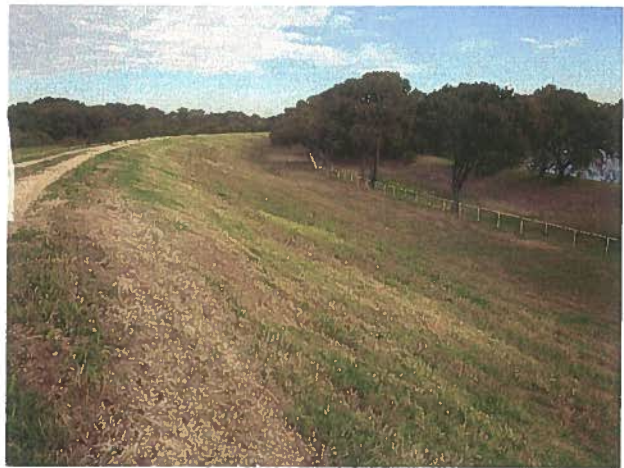
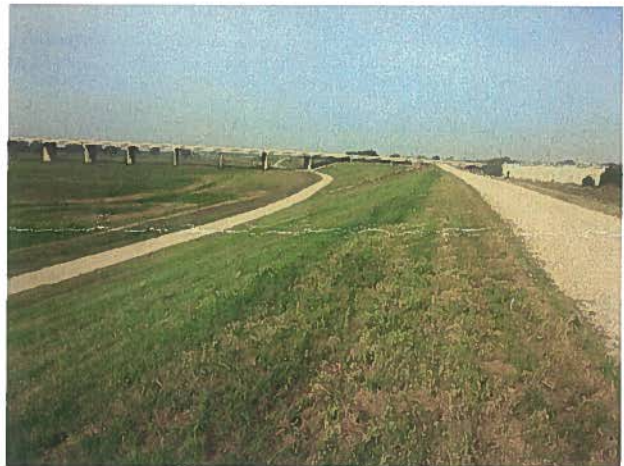
**2. East and West Levees.** The East and West Levees are, in general, true to the design slopes and grades and are reasonably well maintained. Above average rainfall, mild temperatures for the year, and regular mowing have resulted in good recovery of turf grasses on the levee surfaces, although there are still some areas in poor condition from the extended drought conditions that ended last year. The skin slides on the East Levee that occurred in 2015 have been repaired and now appear to be stable. Minor damage due to feral hogs is evident on the surfaces of the East Levee, upstream of State Highway 183. Armoring of the levee surfaces with riprap beneath highway and railroad bridges has reduced or eliminated erosion in these areas and performed well during recent flooding. Damaged or disturbed surfaces of the West Levee, due to construction of the new I35 bridges, have been repaired, but still need to be seeded or solid sod applied to restore the turf. Areas within the shadow line of the bridge are supposed to be armored with concrete riprap before construction is complete.

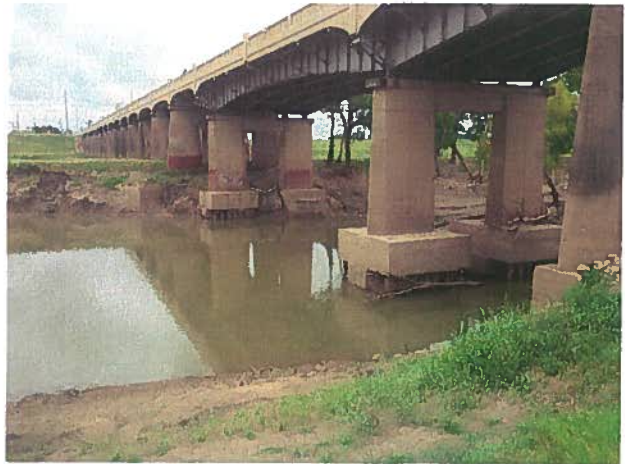
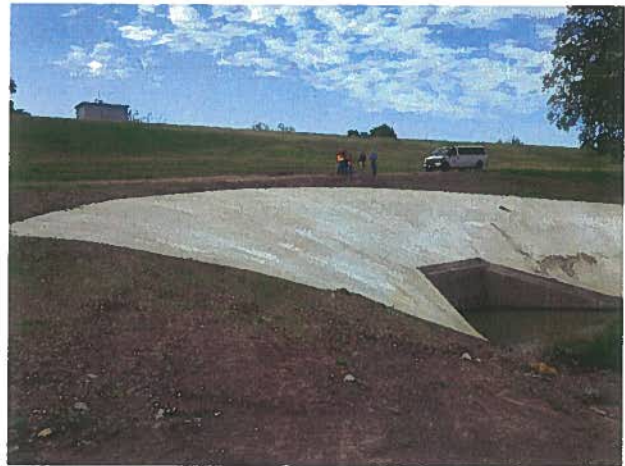
**4. Central Wastewater Treatment Plant (CWWTP) Levee.** The levee around the CWWTP is maintained by the Dallas Water Utilities Department, and received a detailed evaluation during the Periodic Inspection in 2014. In general, the levee is true to design alignment and grades, has adequate turf on the slopes, is mowed regularly, and appears to be in good condition. Desiccation cracking noted in previous inspections, including the Periodic Inspection, has self-healed to some degree due to above average rainfall this year, and no slides or signs of slope instability were noted. Numerous utilities (water, sewer, storm drain) cross this levee, many of which have not been accurately accounted for with respect to their actual size, location, age, current condition, or approximate date and method of abandonment, where applicable.

- a. Continue with the current mowing schedule and general Operations and Maintenance program.
- b. Perform a utility survey to properly account for all the levee penetrations and crossings, including abandoned pipelines, at the Central Wastewater Treatment Plant levee.
- c. Ensure that all pipes crossing under or over the levees receive adequate inspection every 5 years, and document the inspections.
- d. Update the levee crest survey for all levees, and bring low spots up to design elevation.

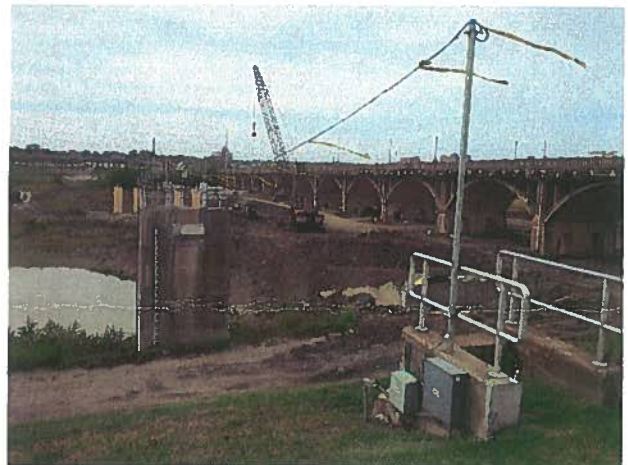
Although a detailed review of each facility was not accomplished during this inspection, Old Baker, the new Baker III, Delta, New Pavaho and Charlie stations were entered and given a cursory review. All the pump stations appear to be in good condition, are fully functional, and reasonably well maintained. Construction of the new Able pump station is well underway and was briefly viewed for conformance to the approved plans. In general, intake areas in the sumps appeared to be free of trash and debris, and discharge channels for the pump stations and gravity sluice structures also appeared to be clear and functional. Several of the discharge channels have been re-shaped and concrete slope protection added where the channel slopes wrap around to a headwall or sluice gate control structure. Erosion damage along the banks of the drainage channel parallel to Topeka Avenue and leading directly to Pavaho pump station was recently repaired and the area covered with erosion control fabric. Just prior to this inspection, the service bridge for Able Pump Station gravity sluice control structure was inadvertently knocked down, for the second time, by the I30/I35 Dallas Horseshoe contractor, leaving the structure temporarily inaccessible

except by bucket truck. The sluice gates, which are remotely operated, were quickly restored to service and TWM personnel are now working with the Horseshoe contractor to replace the bridge.

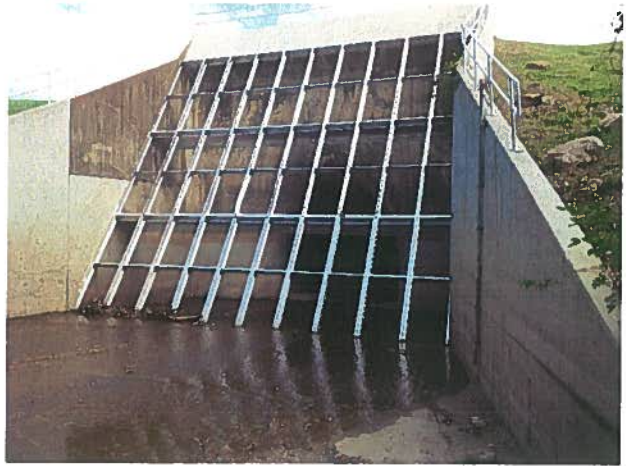
The sump areas are mowed on a regular basis, are in good condition and reasonably well maintained. Many of the problem areas related to surface drainage features and noted in previous inspections have been addressed, either by construction of new headwalls for storm drain outfalls, placement of riprap slope protection, or re-grading of slopes. The reinforced concrete sump lining at Baker III and Pavaho pump stations appears to be performing adequately. The gate control structures for the pressure sewers were given a cursory visual inspection, and the Coombs Creek intake feature was entered; however, the other sewers were not entered.
